ON-SITE AIR BAG INVESTIGATION

CASE NO. - 94-18
FLEET - PRIVATE VEHICLE
LOCATION - [REDACTED] NEBRASKA
ACCIDENT DATE - [REDACTED] 1994

This report concerns a motor vehicle crash involving an air bag equipped 1992 Ford Taurus LX, four-door sedan occurring on [REDACTED] 1994 at 11:40 a.m., near [REDACTED] Nebraska on a county road. This crash is of special interest because it was alleged that the driver-side air bag had caused severe head injuries to the driver of the case vehicle.

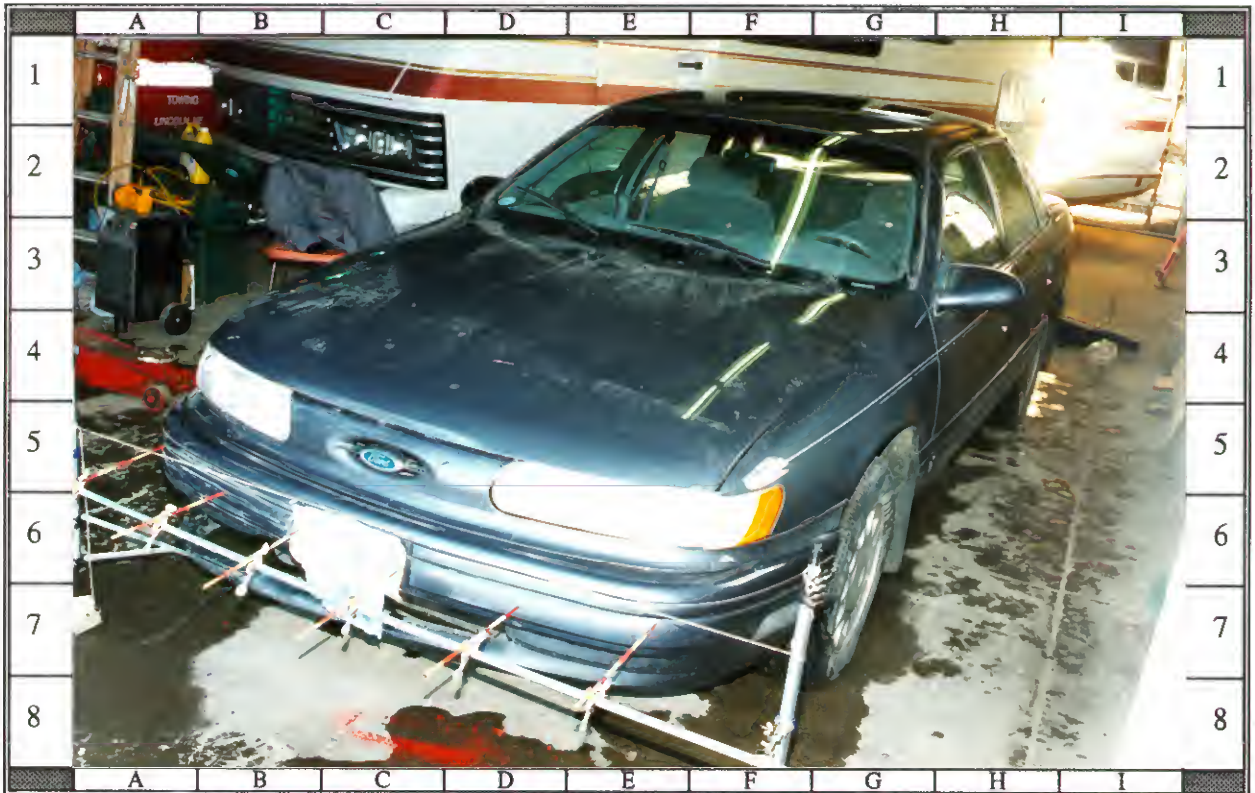
25 -- 1992 Ford Taurus's frontal damage with contour guage present at bumper level viewed from F; NOTE: damage to air dam on R side

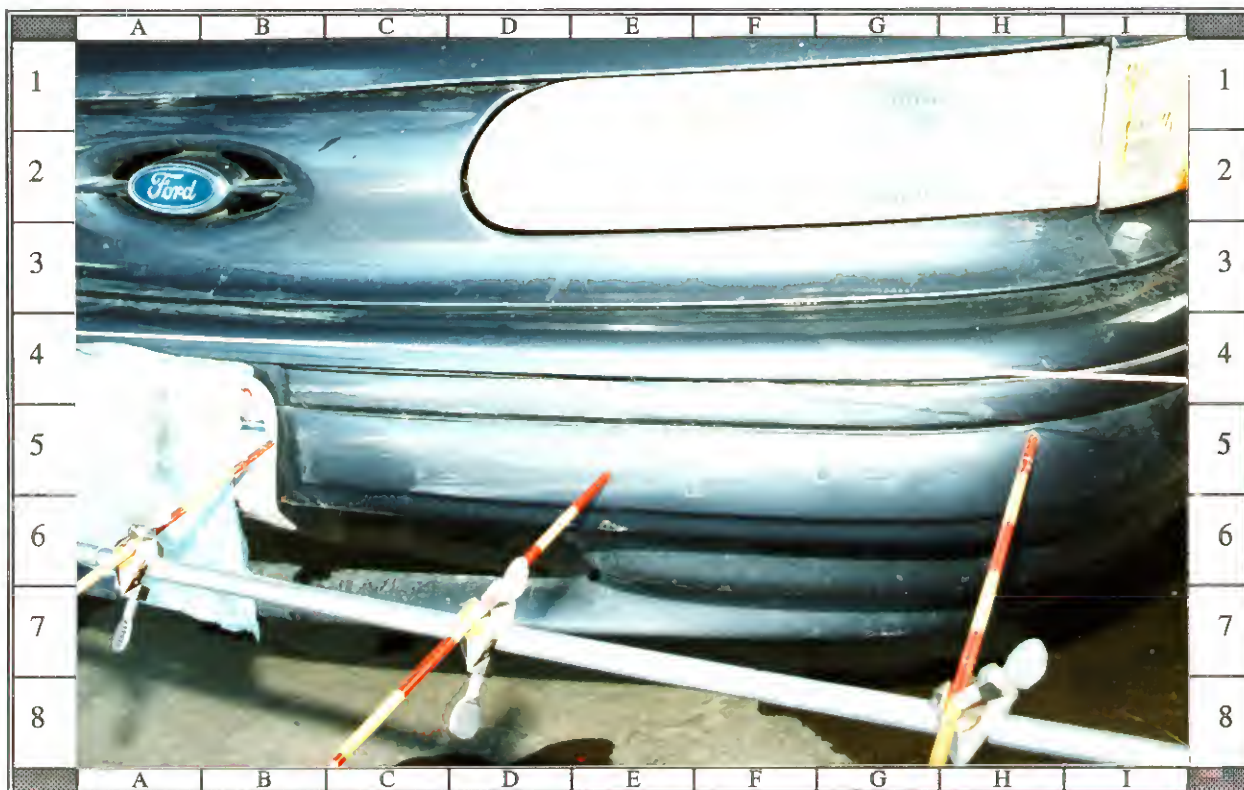
27 -- Close-up of scratches on 1992 Ford Taurus's FL bumper from CW rotational impact with guardrail; NOTE: no LF headlight damage

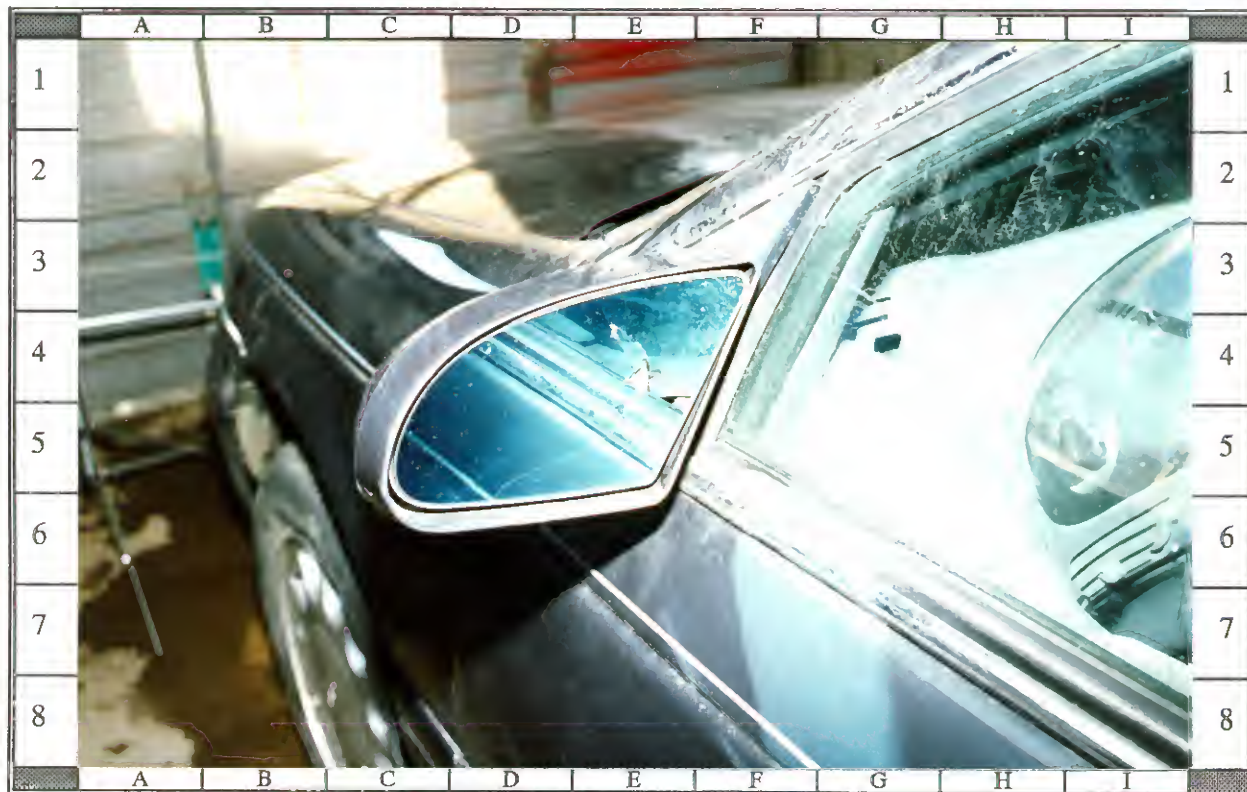
30 -- Close-up of scratches on 1992 Ford Taurus's L outside rearview mirror from impact with limbs of small tree

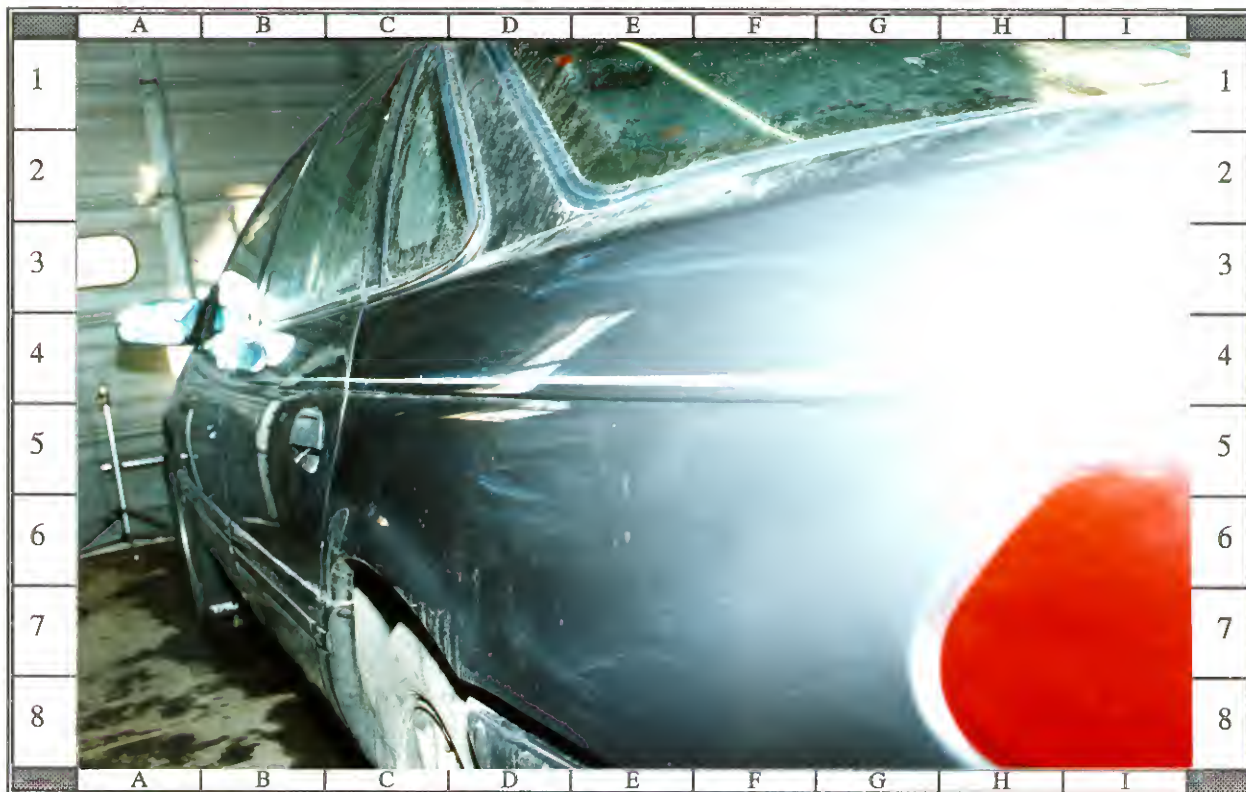
32 -- Close-up of damage to '92 Ford Taurus's L lower driver door area most likely induced from the rearward movement of the LF fender

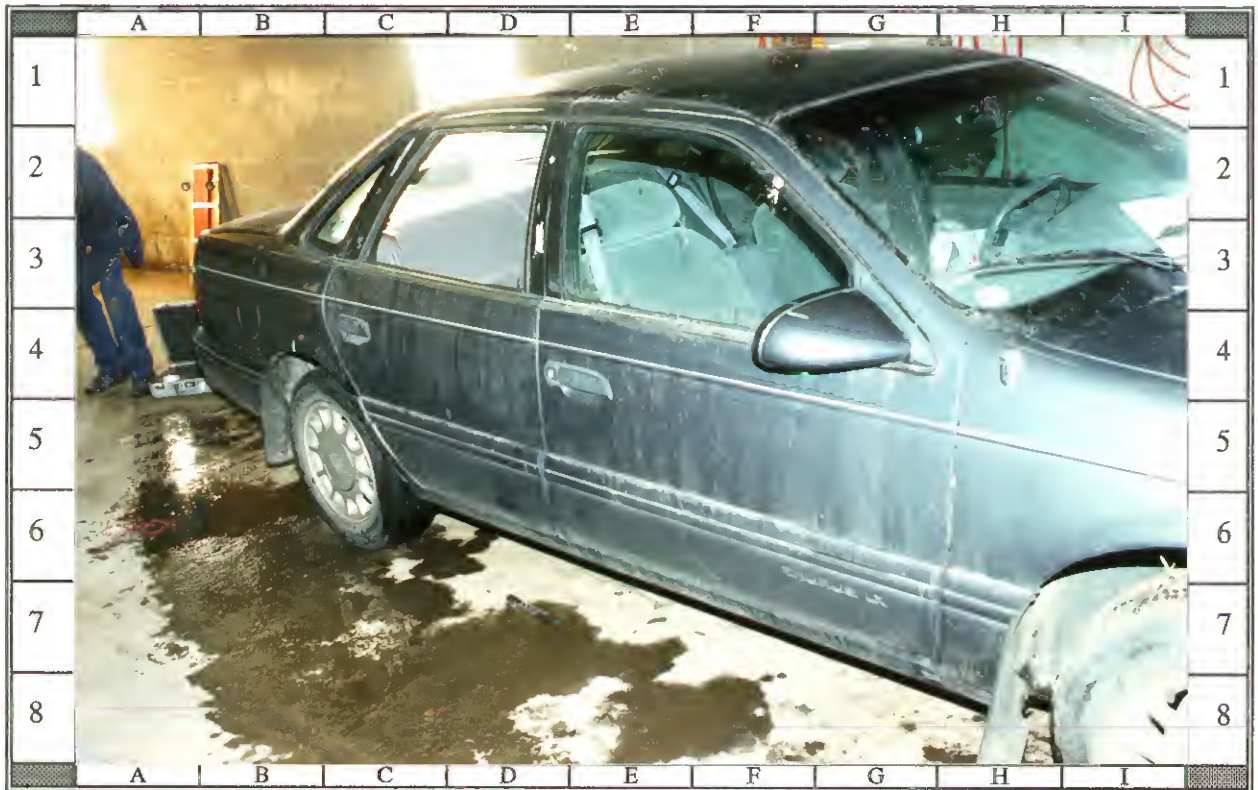
35 -- 1992 Ford Taurus's undamaged right side viewed from right front;
right rear window was shattered during extrication of driver

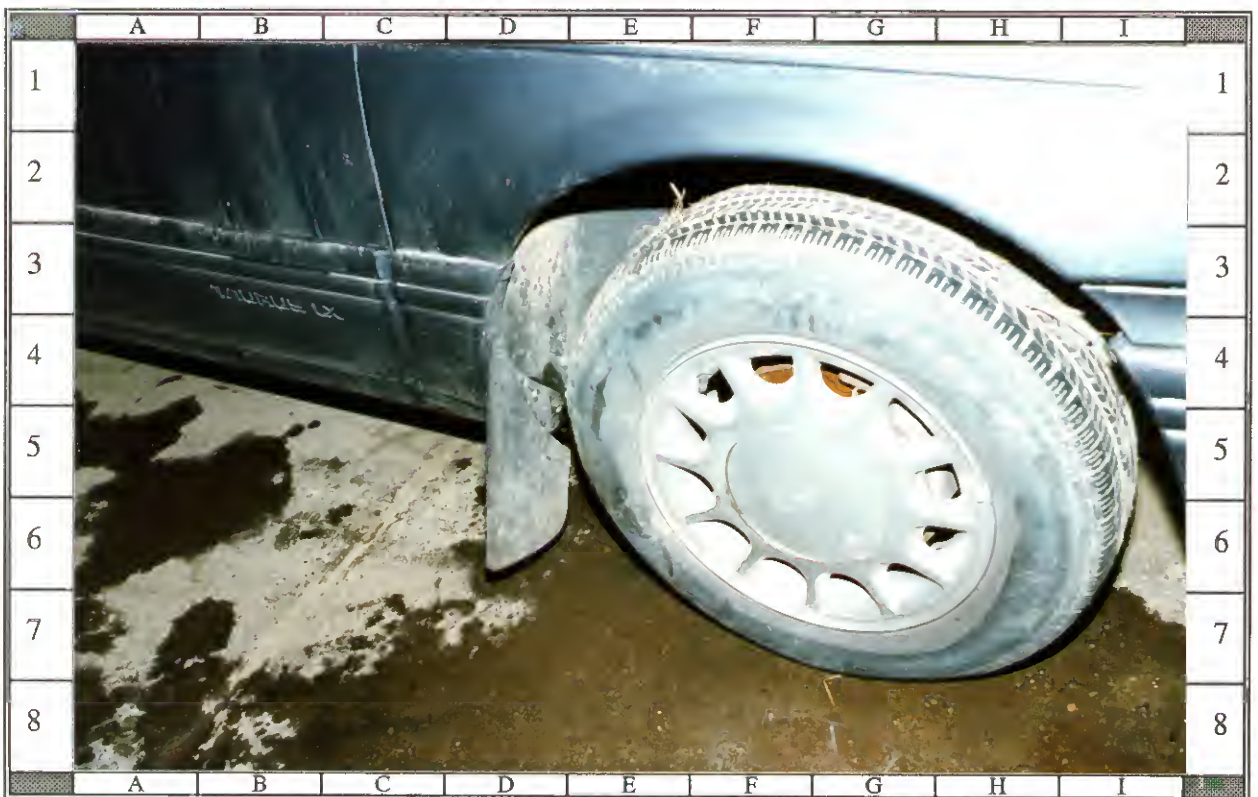
36 -- Close-up of mudflap behind 1992 Ford Taurus's right front wheel;
NOTE: damage most likely occurred during travel down embankment

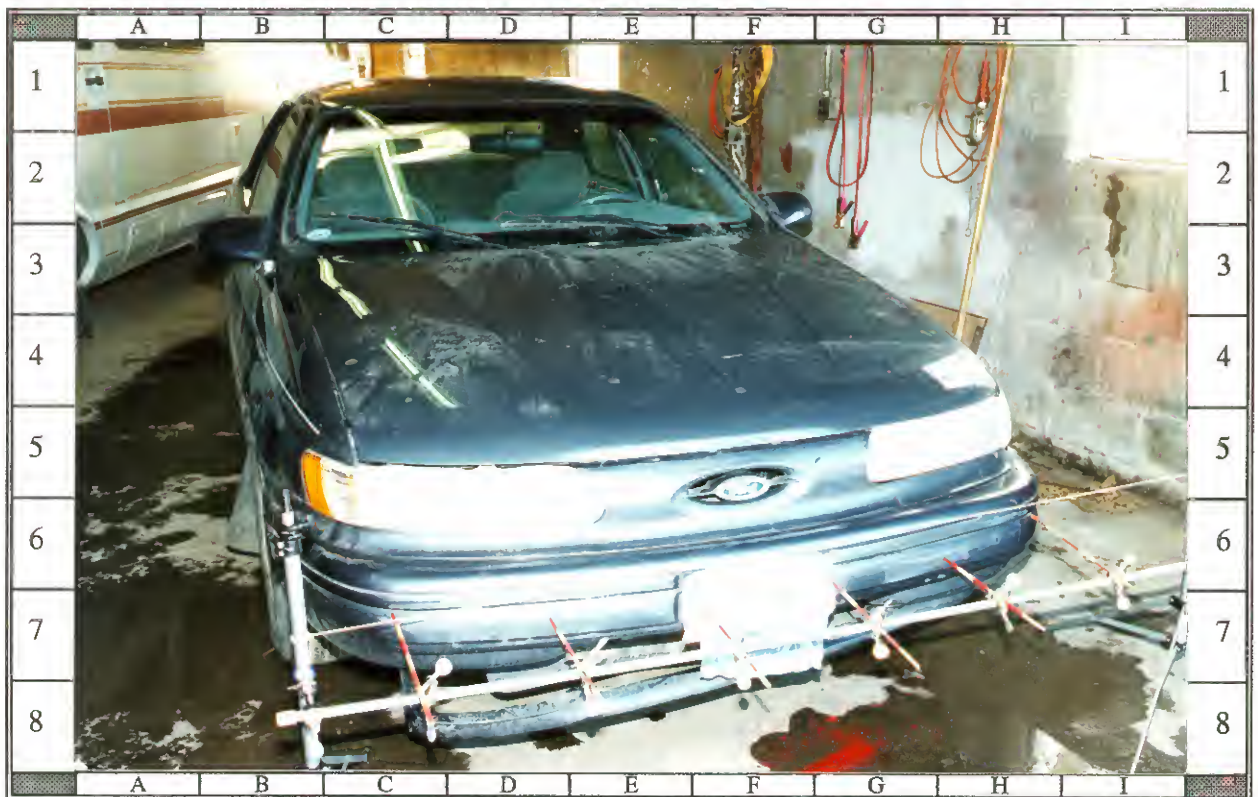
38 -- 1992 Ford Taurus's frontal damage with contour gauge present at bumper level viewed from FR; NOTE: damage to air dam on R side

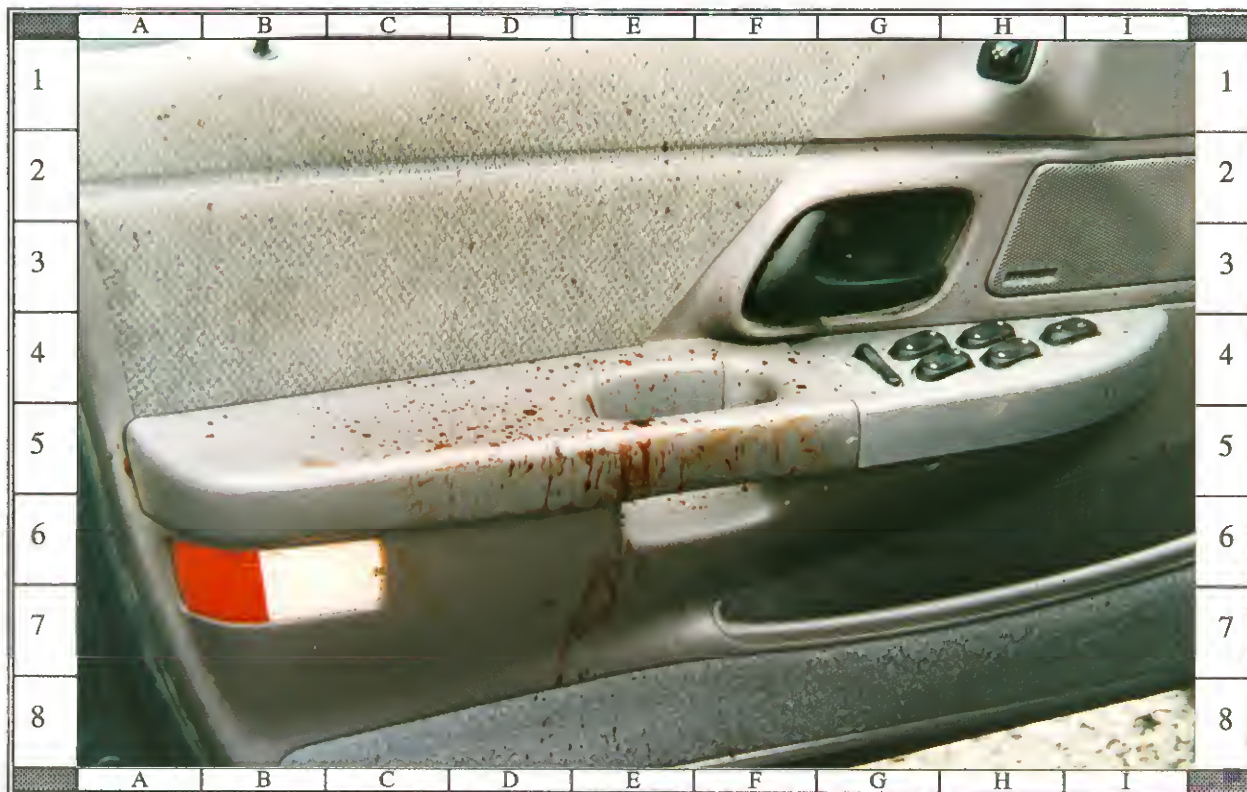
43 -- On scene close-up of 1992 Ford Taurus's blood-splattered driver door which occurred when air bag struck driver's bleeding face

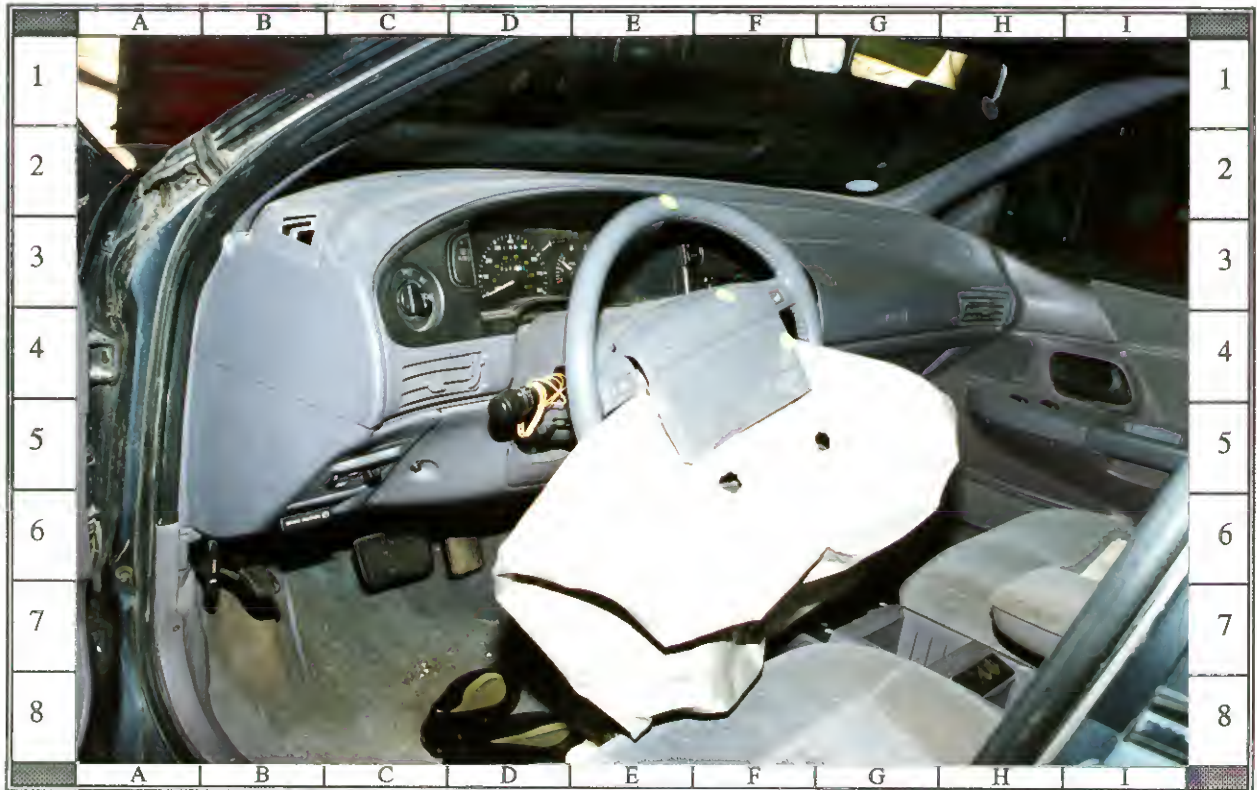
44 -- On scene view of 1992 Ford Taurus's blood-splattered driver air bag; driver was bleeding from face when air bag deployed

rest. This posture may explain the large amount of blood on the driver's door, torso belt, and outward edge of the driver's seat. The eyewitness reported that he went to call for help, and upon returning to the case vehicle, he indicated that the driver was now facing straight ahead and slumped over a bit, but held up by her torso belt. The witness reported that the case vehicle's driver was wearing her lap and shoulder belt in the proper manner. In this contractor's opinion, this sequence of events (i.e., the case vehicle's driver striking the steering wheel with her face as a result of the guardrail impact and causing the open fracture followed by the case vehicle driver being slumped over on or near the steering wheel when the air bag deployed in the primary impact) explains why the blood was splattered on the air bag and the driver's side dashboard.

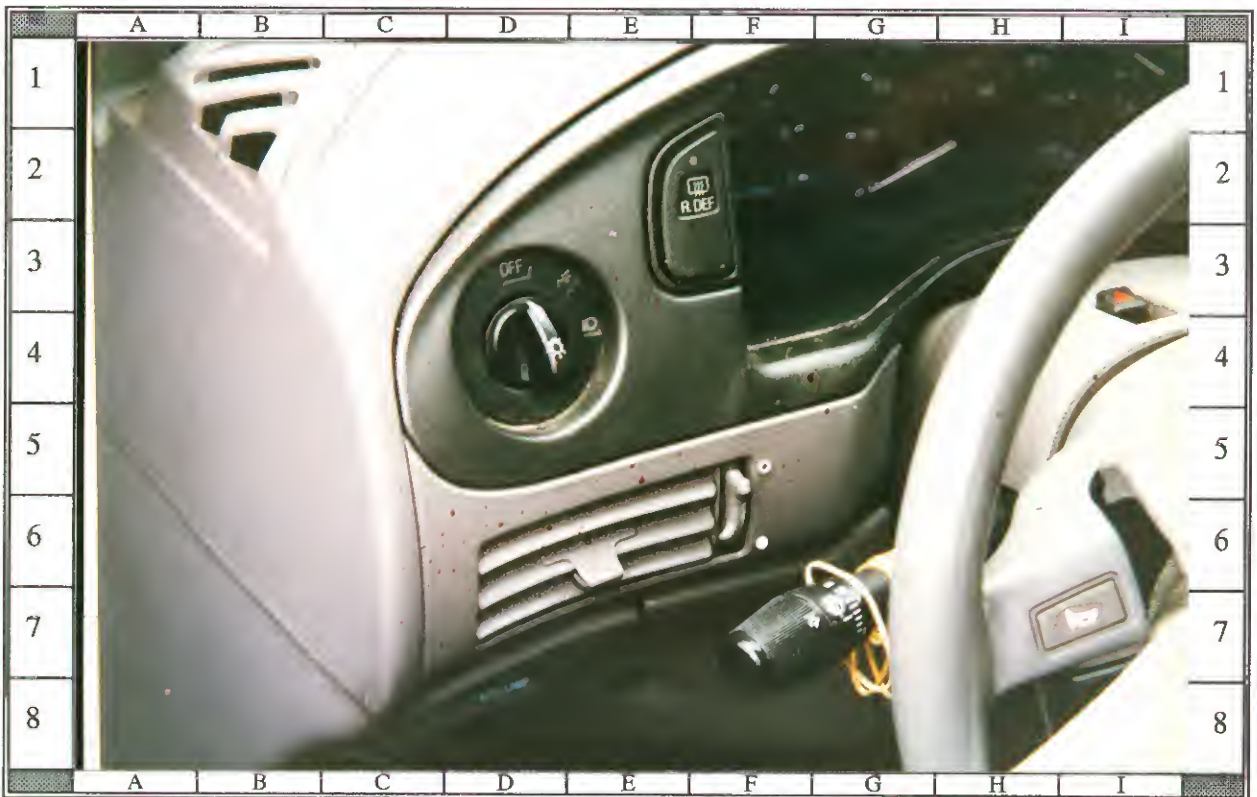
45 -- Interior view of 1992 Ford Taurus's driver area showing contacts to steering wheel and cover flap; NOTE: position of vent holes

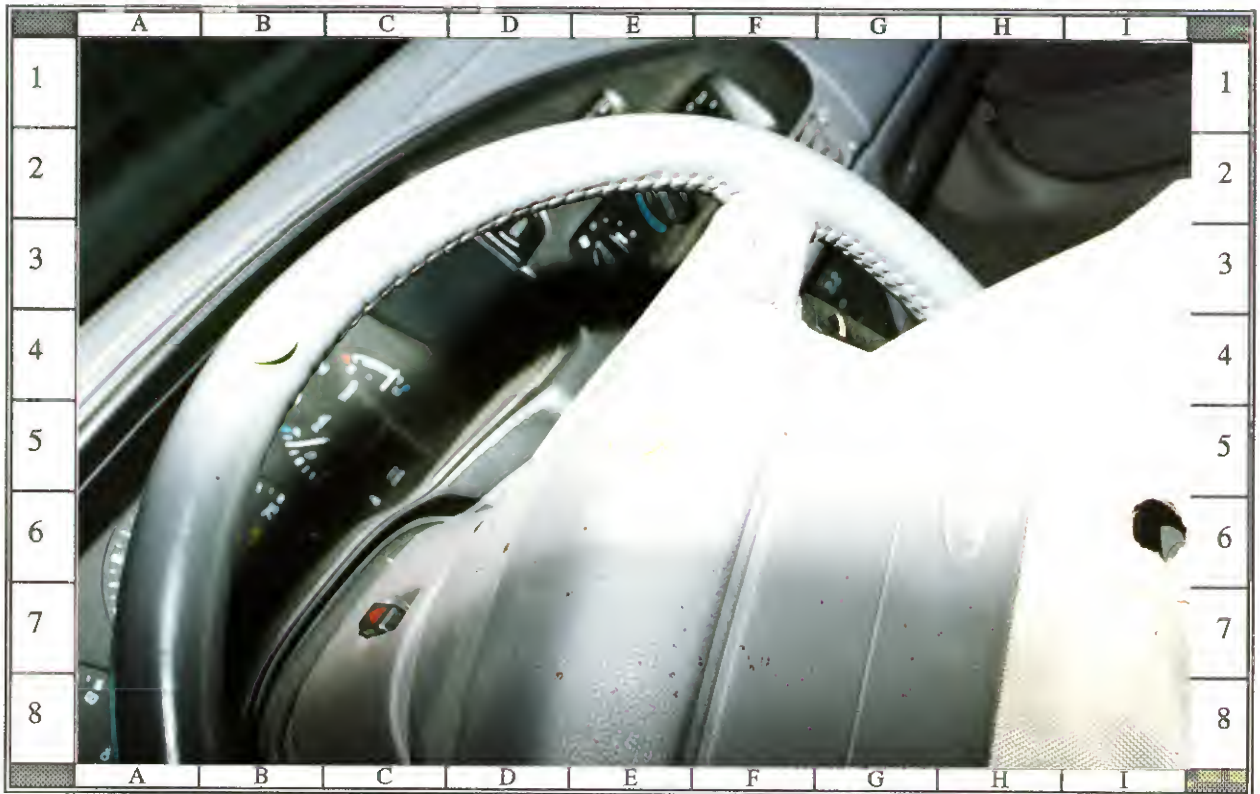
46 -- On scene close-up of 1992 Ford Taurus's blood-splattered L dash; NOTE: no contact evidence present

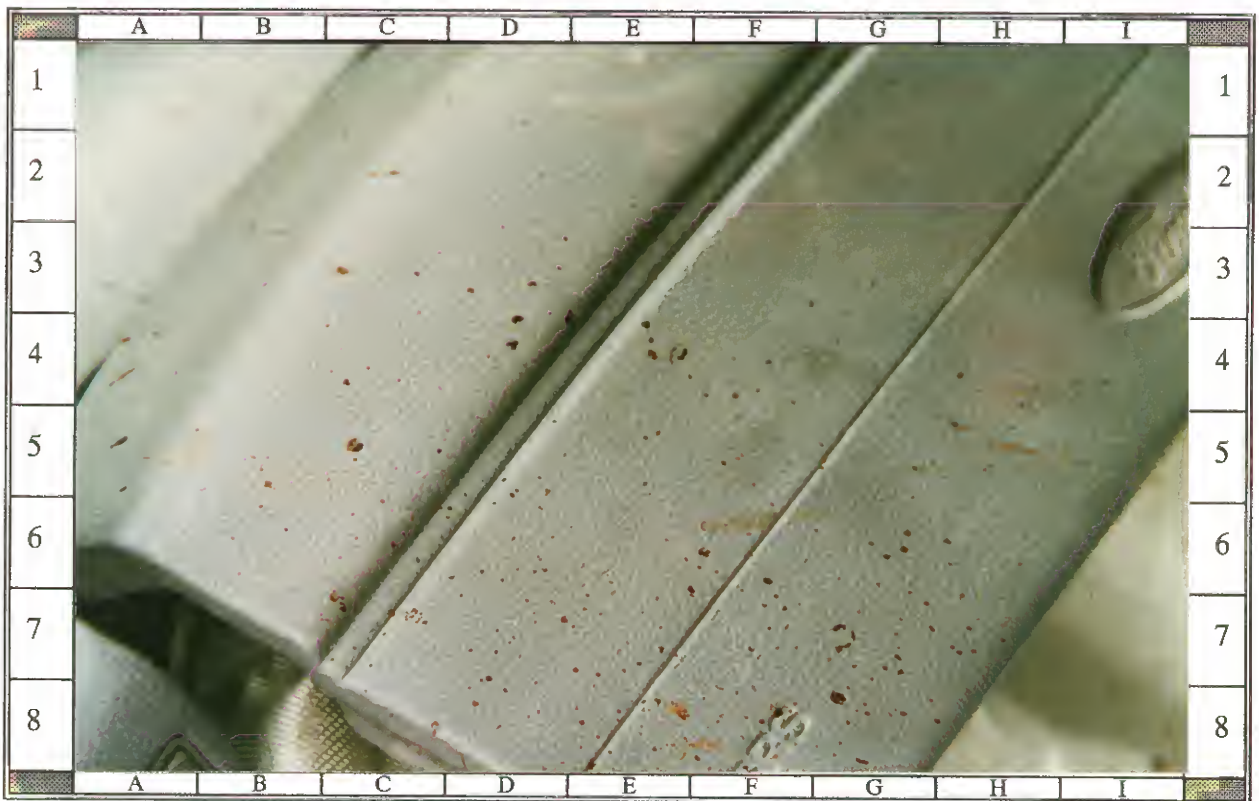
47 -- Close-up of contacts to 1992 Ford Taurus's steering wheel rim & air bag cover flap; NOTE: blood on cover flap

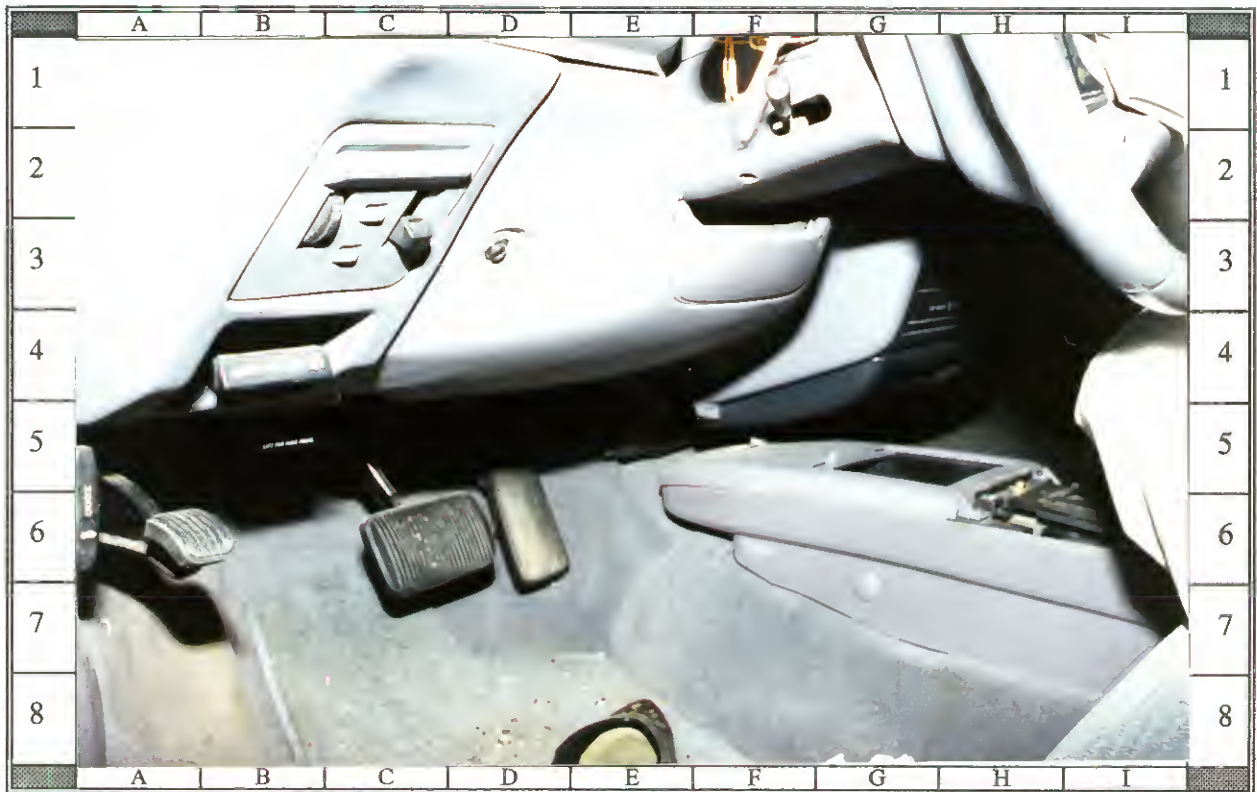
51 -- Close-up of 1992 Ford Taurus's left lower dash area showing no evidence of driver contact

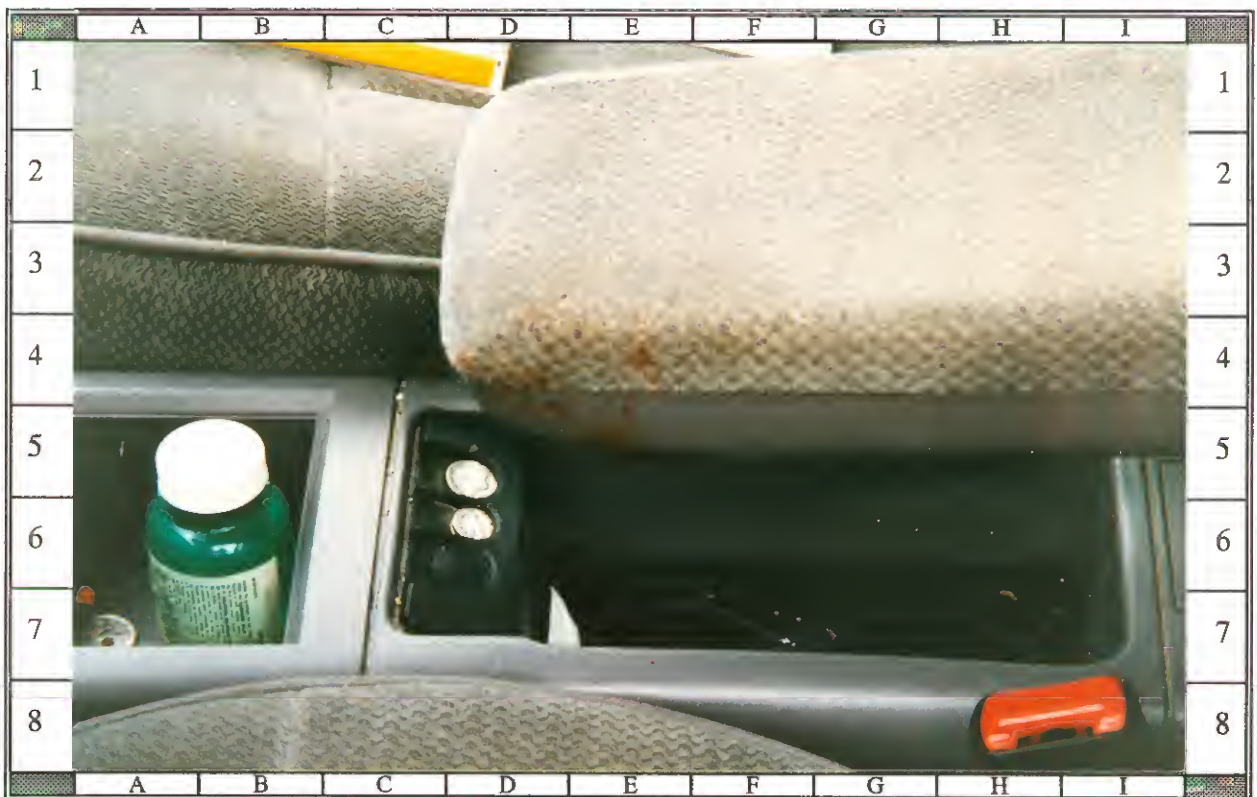
52 -- On scene close-up of 1992 Ford Taurus's blood-splattered center-mounted console showing bleeding occurred prior to deployment

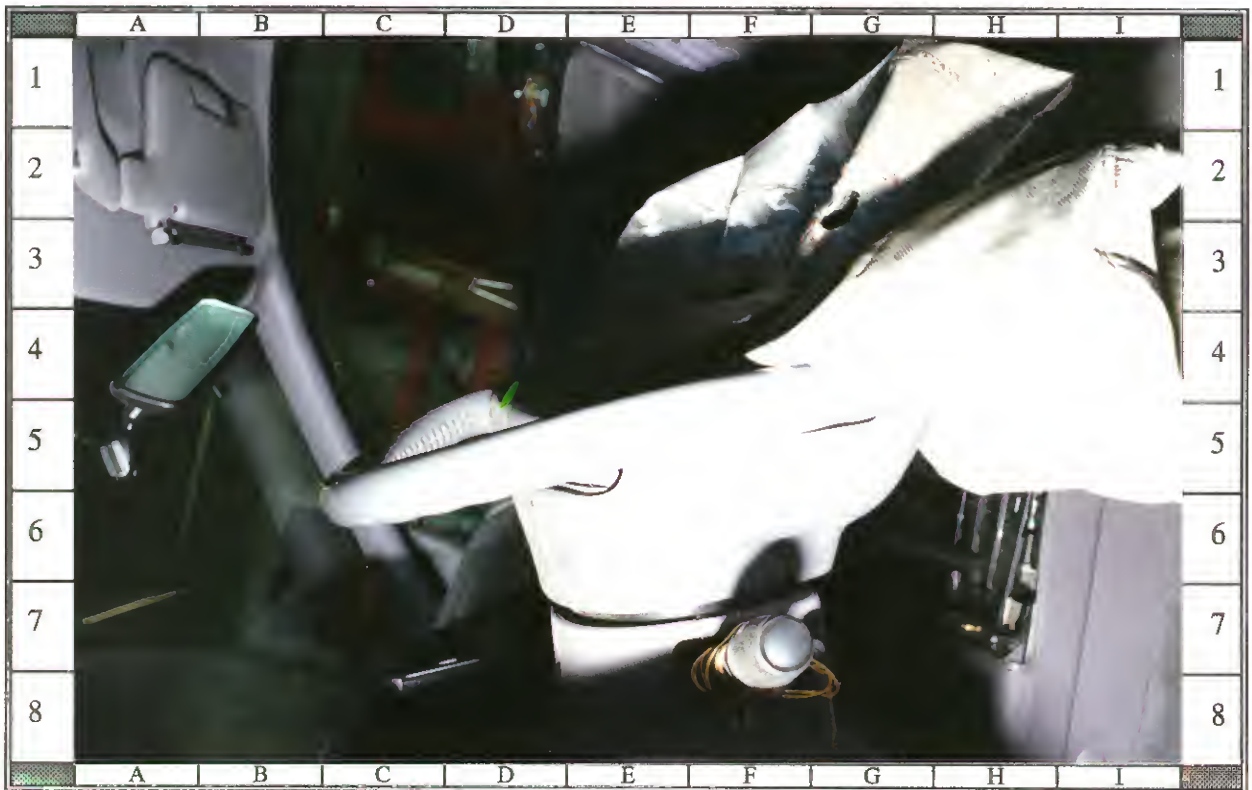
53 -- Close-up of 1992 Ford Taurus's bent steering wheel rim--top of rim moved ~ 2.5 cm; NOTE: no contacts to mirror or RF sunvisor

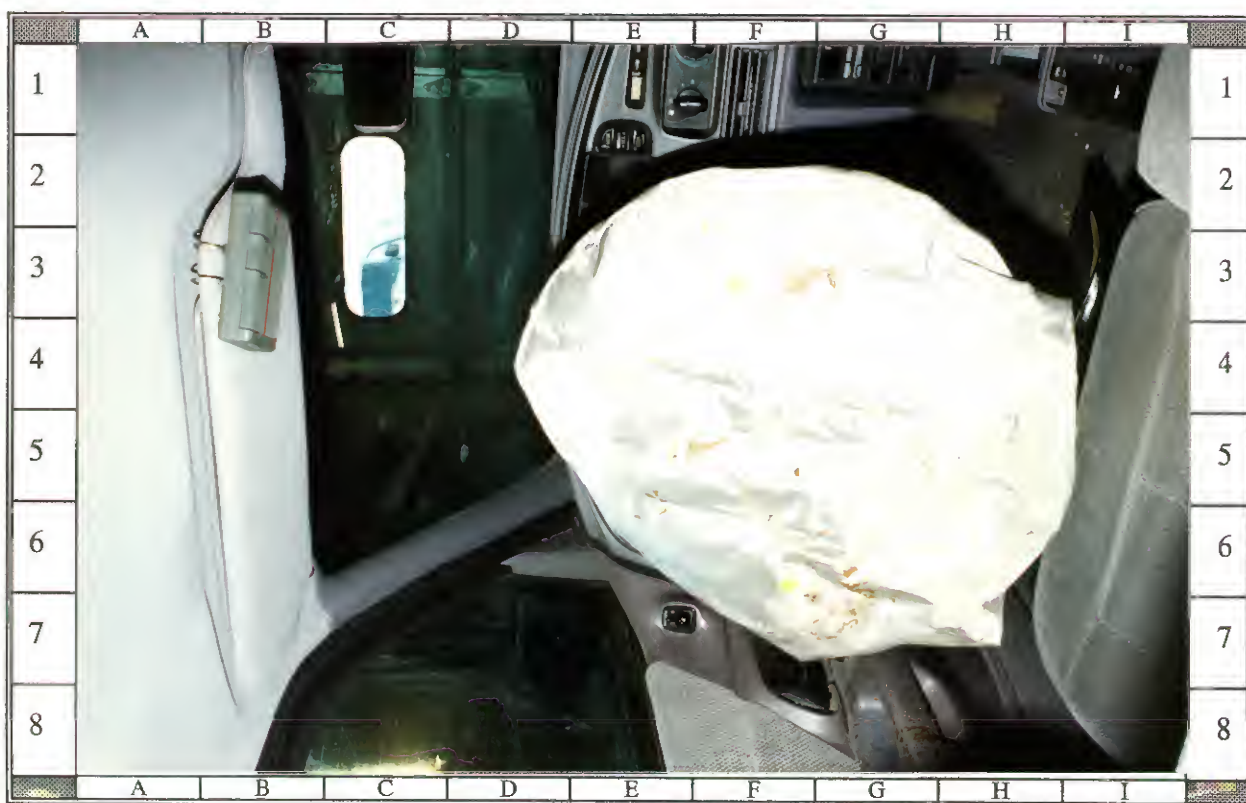
56 -- Rear center view of 1992 Ford Taurus's driver seating area showing deployed air bag, seat, L A-pillar, L sunvisor/header area

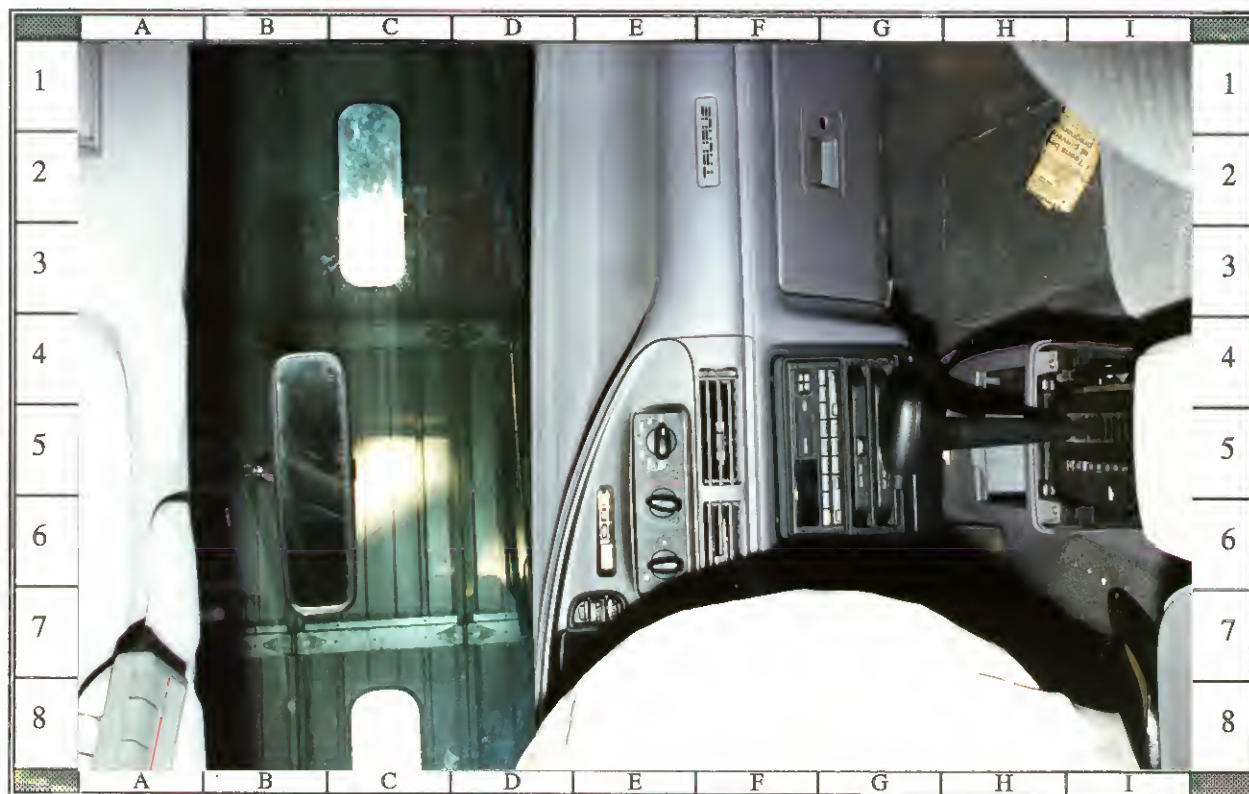
57 -- Rear center view of '92 Ford Taurus's noncontacted rearview mirror, center dash, console, & header, and windshield

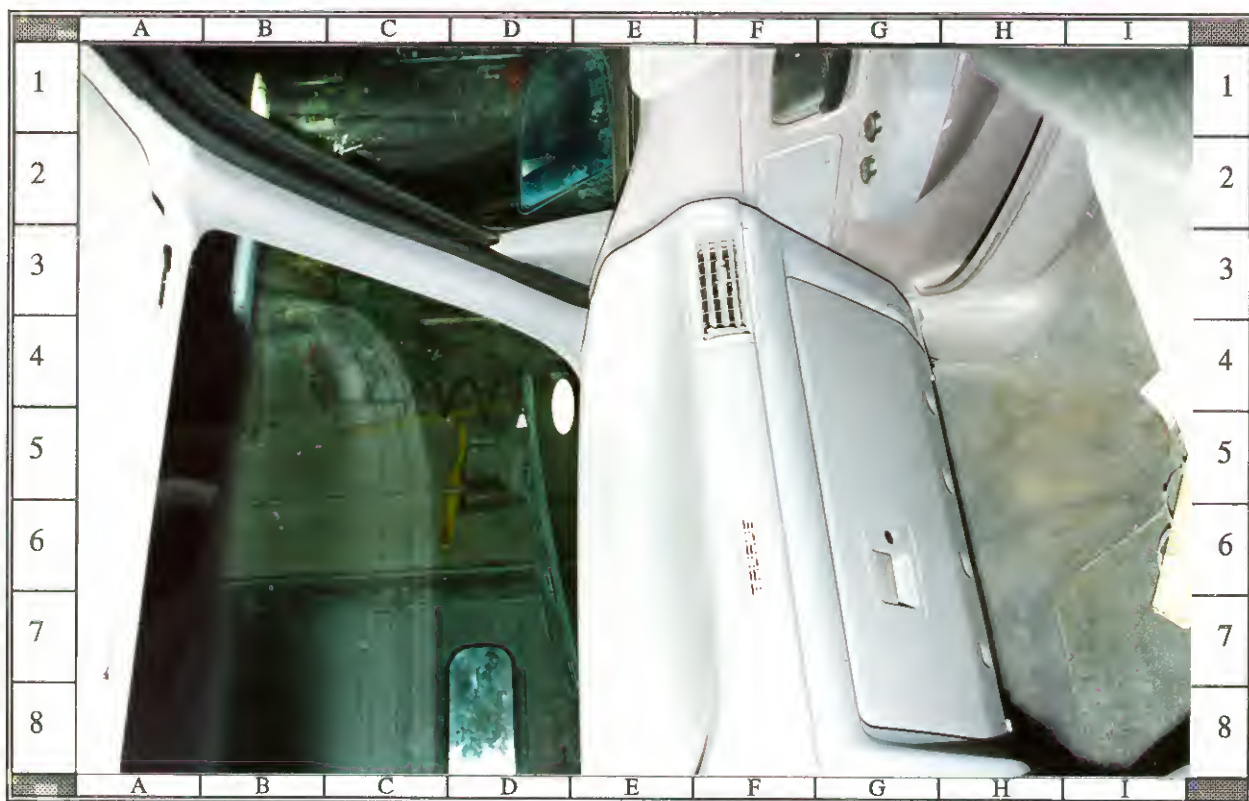
58 -- Rear center view of '92 Ford Taurus's noncontacted right dash

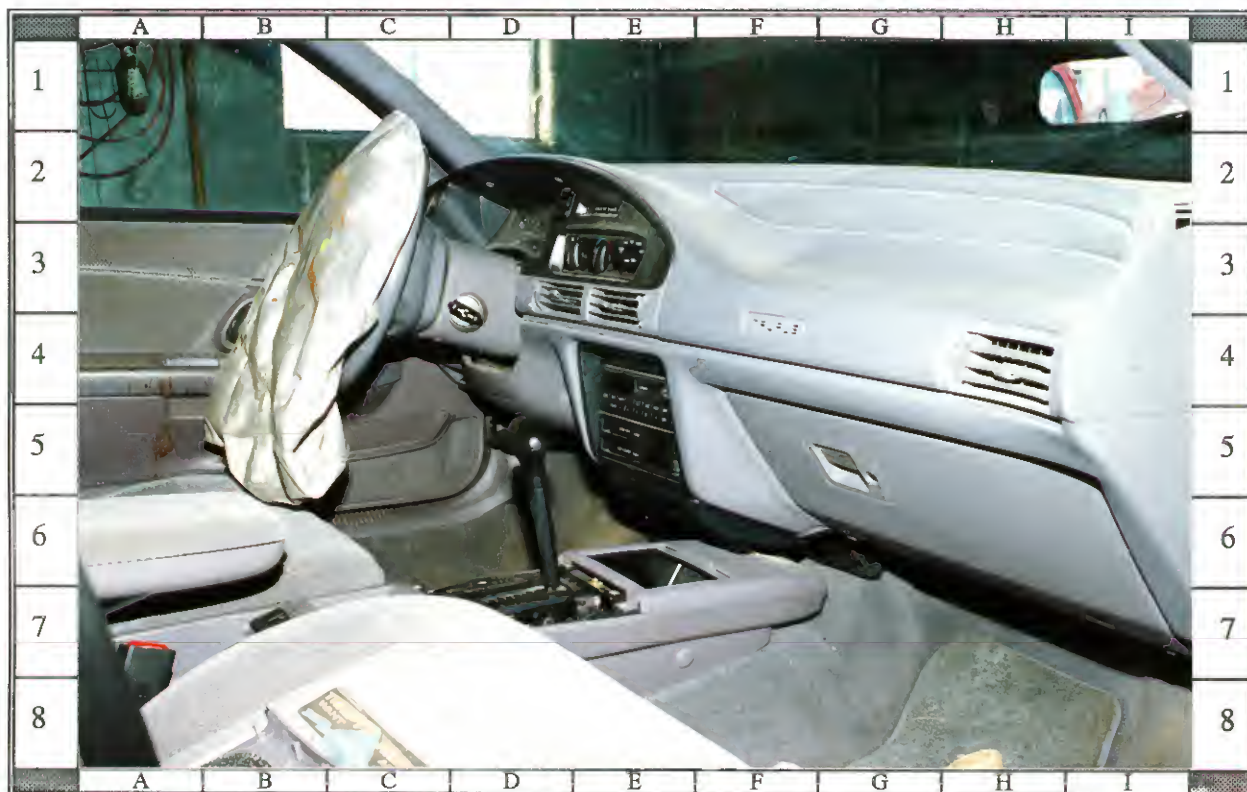
59 -- Front occupant seating area of 1992 Ford Taurus viewed from RF door; NOTE: no evidence of contact to windshield or dash

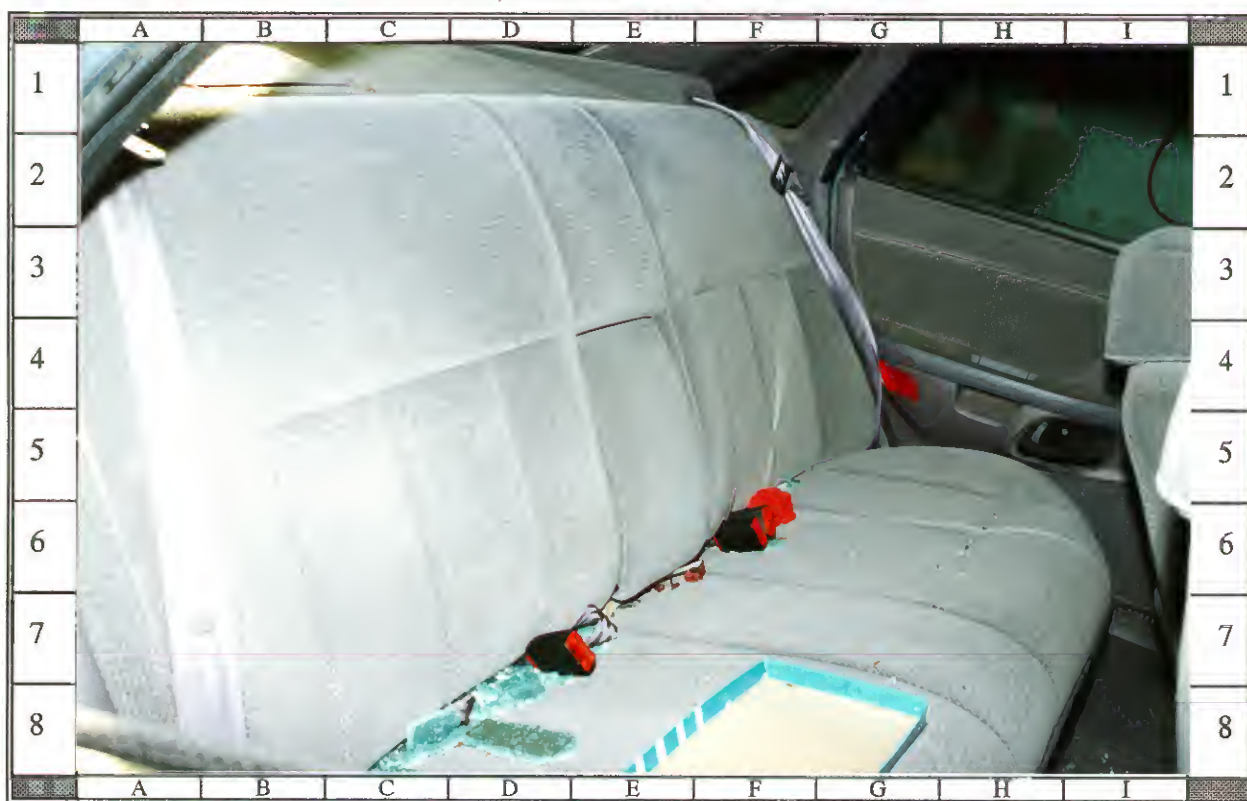
60 -- Rear occupant seating area of 1992 Ford Taurus viewed through RR window which was broken during extrication; NOTE: restraints
